Ten Tec Titan 425 Amplifier with Ameritron AL800H P. S. Transformer

John, W1AN 8/7/2014

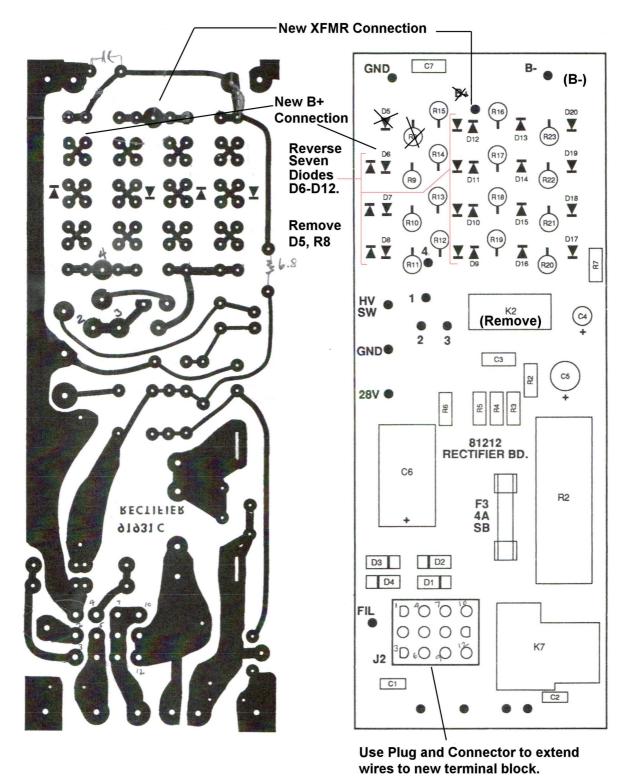
VOLTAGE DOUBLER MODIFICATIONS POWER SUPPLY RECTIFIER BOARD CIRCUIT TRACE POWER SUPPLY RECTIFIER BD. COMPONENT LAYOUT

On the Rectifier board Relay K2, D5 and resistor R8 were removed. They were no longer needed. Removing D5 added clearance to the ground trace for B+ level voltages.

On the Rectifier board D6-D12 diodes were removed, reversed and replaced. (Seven diodes) Several of the original diodes were bad so it was easy just to reverse several with the new ones. (Suggest 1N5408).

The Rectifier and Filter boards show the connection point and diode changes required to change from a full wave bridge to a voltage doubler. The schematic shows the wiring, and other interconnections within the power supply.

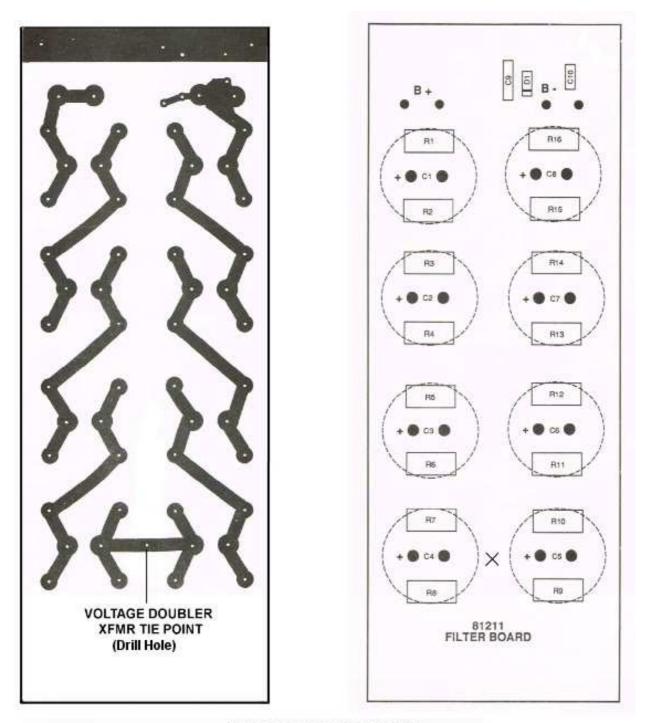
VOLTAGE DOUBLER CHANGES

Red HV leads from the transformer connector were relocated. One was to the rectifier board. One small hole was drilled on the Filter board as a tie point for the other. Two red wires were cut off from the connector.
